Manhole Inspection Summary

Manhole # S47I__041MH

Location Address: **2033 EASTERN AV**

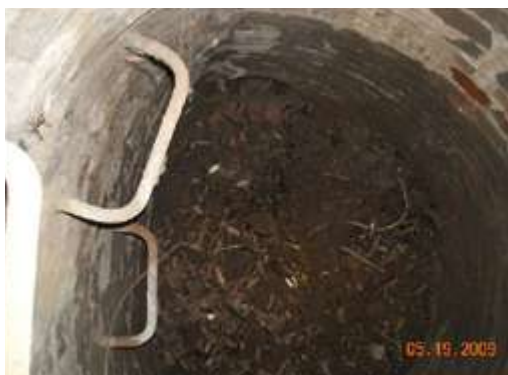
Defect 2

Condition: ☐ Sound ☐ Cracked ☐ Root Intrusion ☐ Deteriorated ☐ Leaks ☒ **Debris**

DEBRIS IN TERMINAL CHANNEL

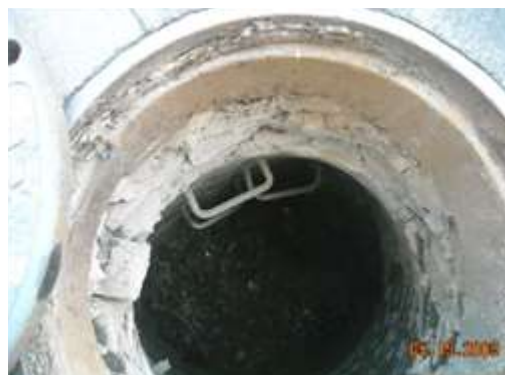
Defect 1

Offset: **6** (in.)

FRAME OFFSET

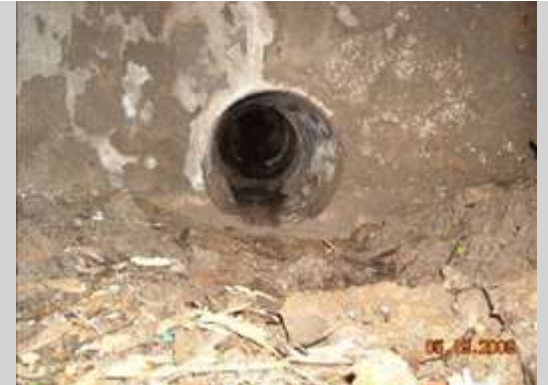
12 O'Clock Outflow

8 in. Circular Gravity Sewer
Pipe Out @ 12 O'Clock

Pipe Seal Cond: **Sound**
